**Techno Marine Services**  
Marine Surveyors and Consultants

**SURVEY REPORT NO. 20 - 3338**

CONTAINER: MSCU1550902

SHIPMENT: 648 BAGS FLOWER SEEEDS

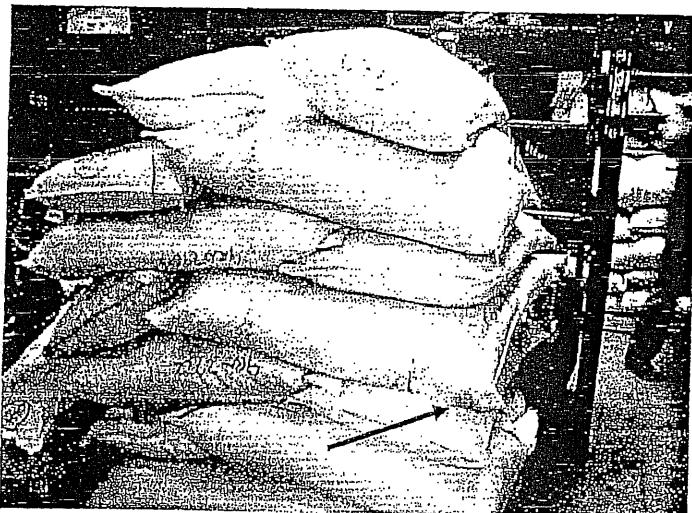
The sides of the bags that were in contact with the condensed water inside the side panels, were wet and had rust stains.

During our inspection we noticed some bags had wet stains along either one end or on the side.

Wet stains on side of bags

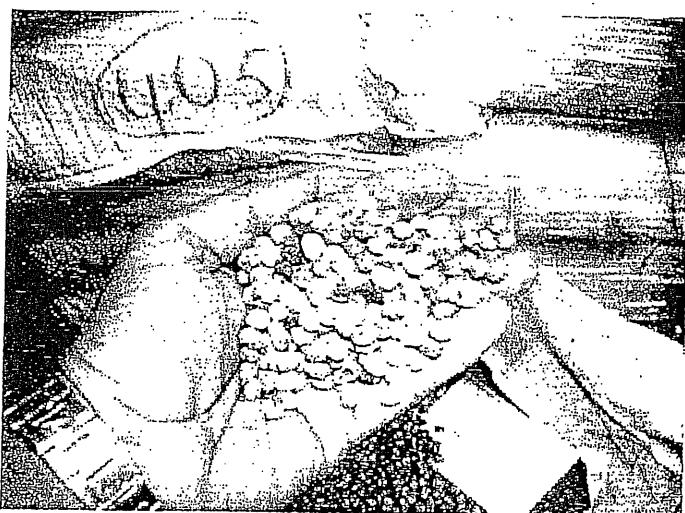
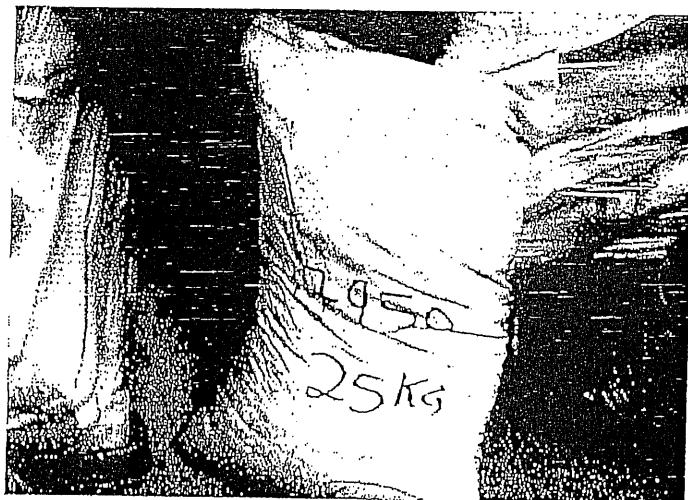
Wet clumps of seeds.

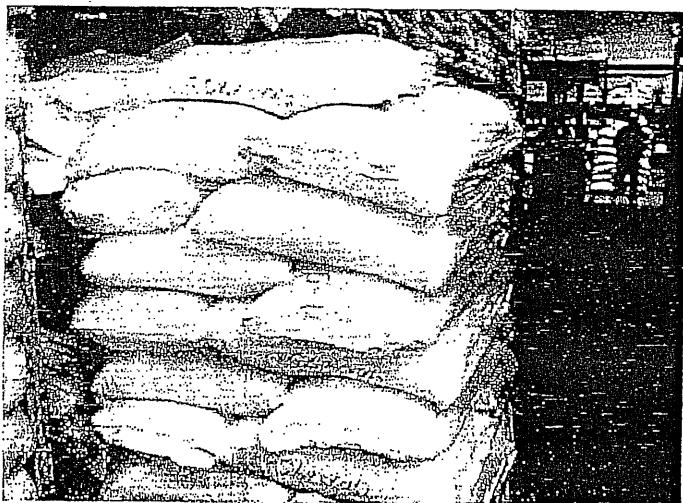
Wet Stains on Bags

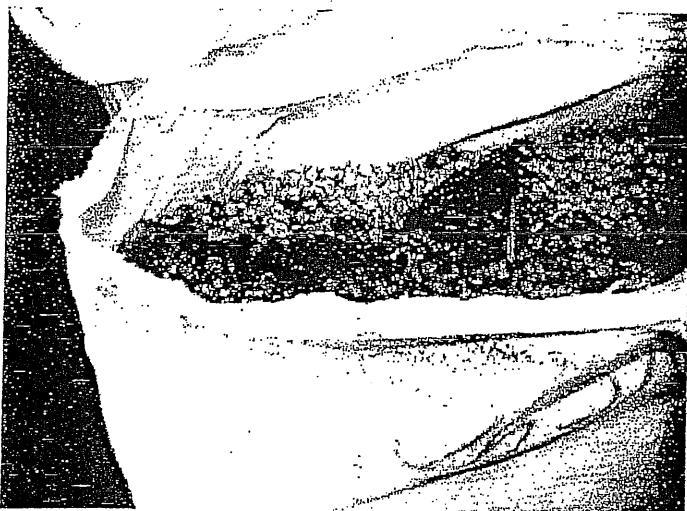
Zinnia      The bags inspected did not have any stains. The seeds were found to be in apparent visible satisfactory condition.

Zinnia Seeds Dry & In Good Condition

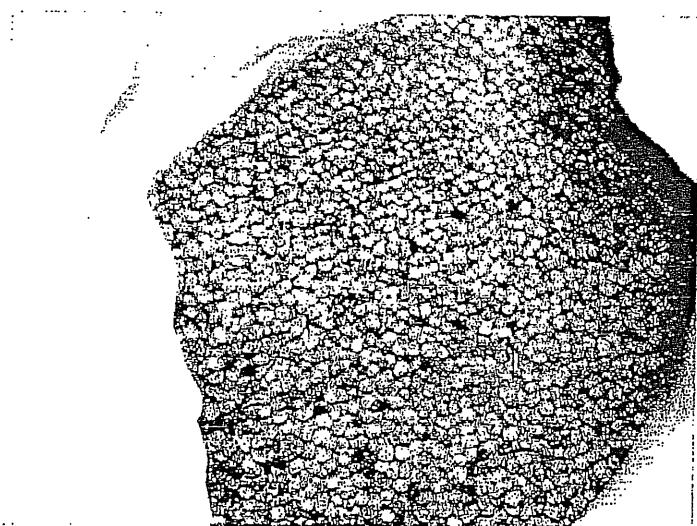
Thunbergia Seeds in good condition.
